Fungal Resistance of Calcium Silicate Boards

22-10-2015

Order no.: 647950

Danish Technological Institute, Wood Technology

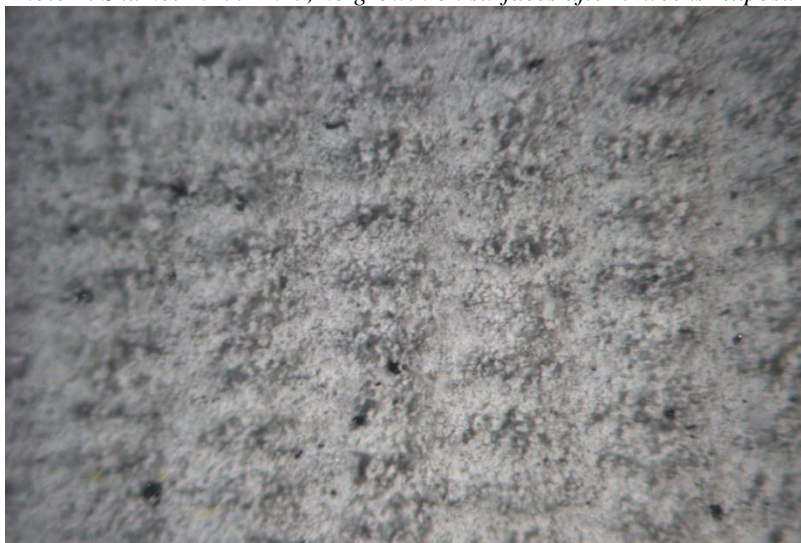
Photo 2. Skamol 15-37-10-3, no growth observed in microscope.

After 7 weeks' exposure, no fungal growth were visible to the naked eye. In the microscope, the spores were observed but no mycelium.

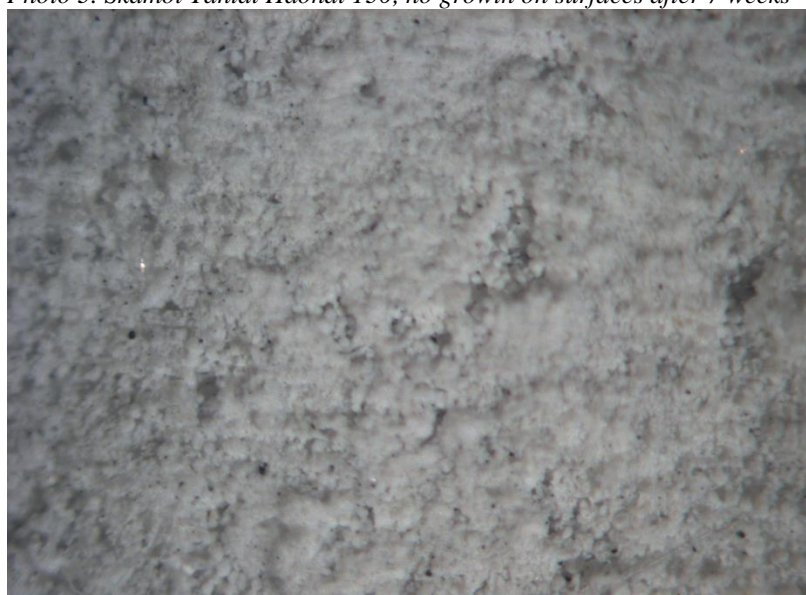
Photo 4. Skamol Yantai Haohai 130, no growth observed in microscope.

After 7 weeks' exposure, no fungal growth were visible to the naked eye. In the microscope, the spores were observed but no mycelium.

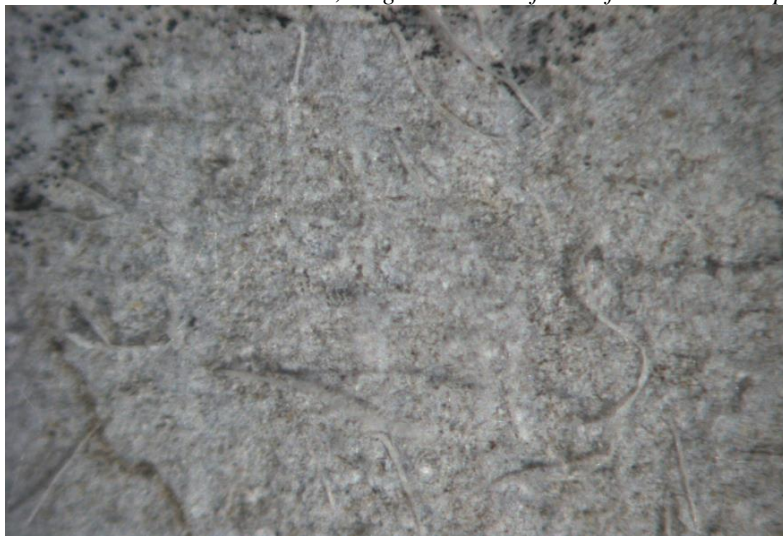
Photo 6. Skamol Skamotec 225, no growth observed in microscope.

After 7 weeks' exposure, no fungal growth were visible to the naked eye. In the microscope, the spores were observed but no mycelium.

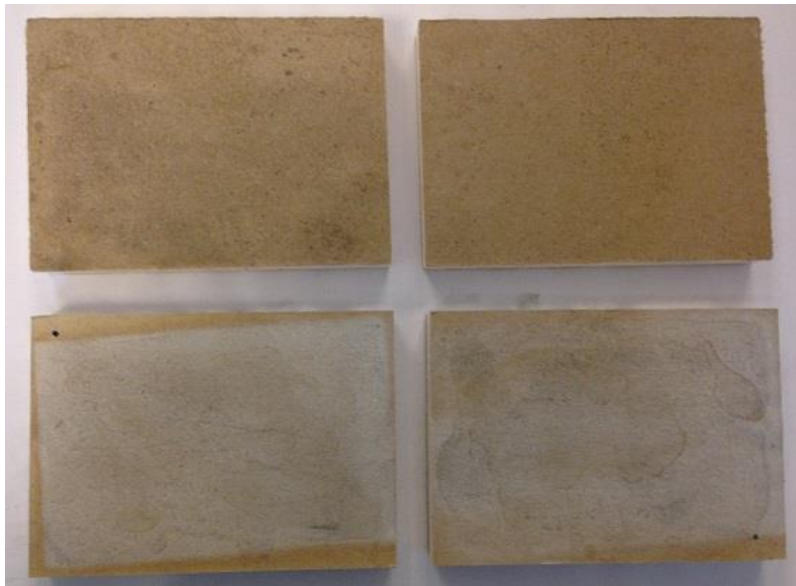
Photo 7. Gypsum boards, growth on surfaces after 7 weeks' exposure

After 5 weeks' exposure, the surfaces of the Gypsum boards reference specimens were covered with visible fungal growth, and the paper on top of the specimens was damaged by moisture. Also in the microscope, heavy growth was observed.

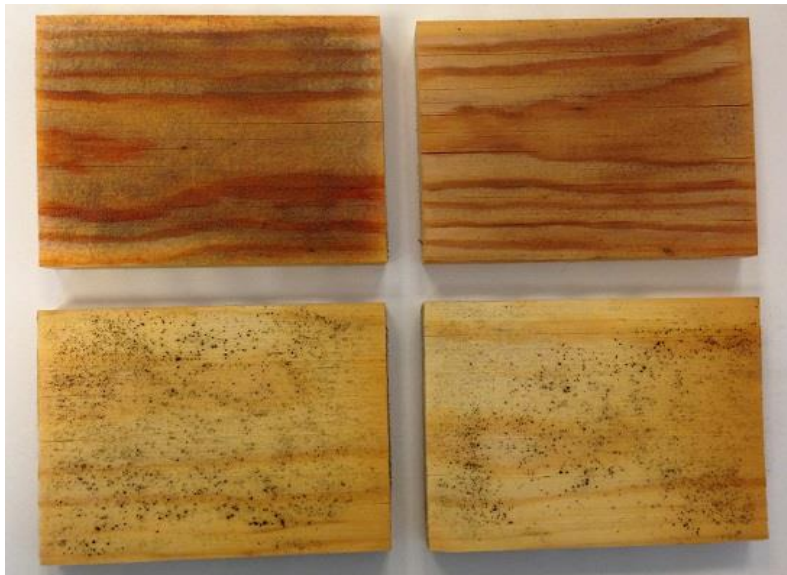
Photo 9. Pine sapwood, growth on surfaces after 7 weeks' exposure

After 5 weeks' exposure, the surfaces of the Gypsum boards reference specimens were covered with visible fungal growth, and the paper on top of the specimens was damaged by moisture. Also in the microscope, heavy growth was observed.
